Right Engine

## ENGINE RECORD

Manufacturer: **Pratt & Whitney** Model: **R-985-AN-14B**

Serial No: **JP-203758**

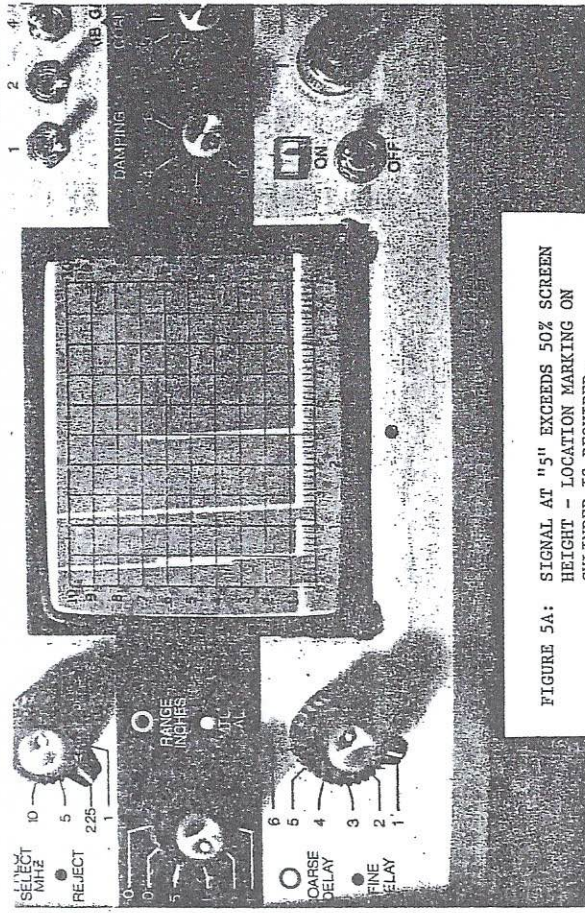
FIGURE 5A: SIGNAL AT "5" EXCEEDS 50% SCREEN HEIGHT - LOCATION MARKING ON CYLINDER IS REQUIRED.

A. A defective cylinder which must be removed from service is defined as: Any cylinder in which the CUMULATIVE signal physical location markings exceed 1" in circumferential length. See Figure 6.

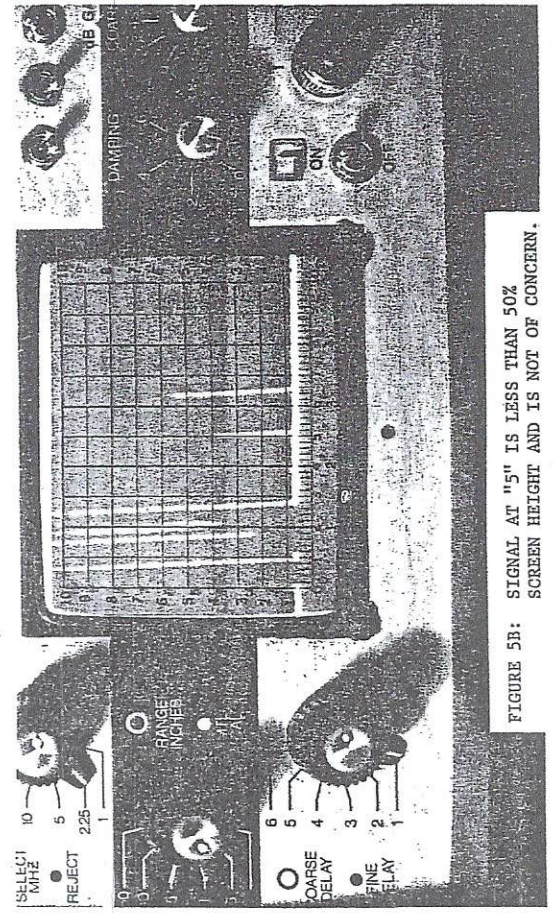
FIGURE 5B: SIGNAL AT "5" IS LESS THAN 50% SCREEN HEIGHT AND IS NOT OF CONCERN.

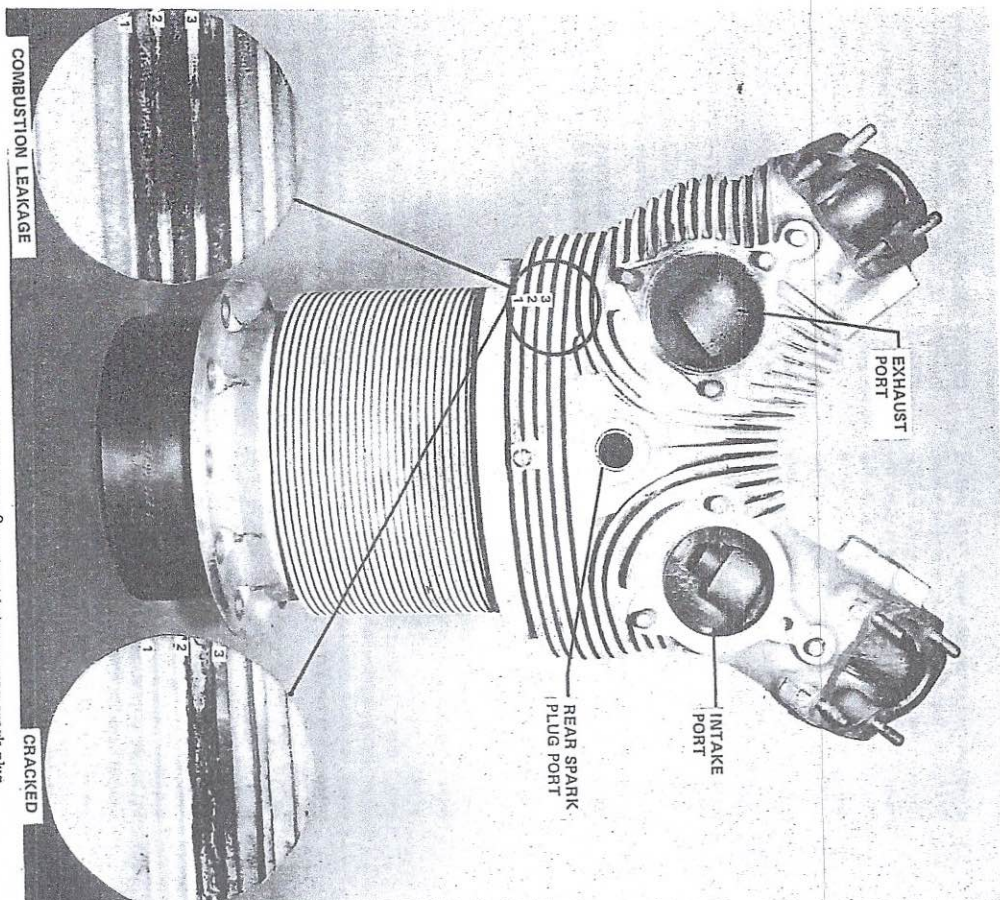
(7-1) Checking for Cracks

Visually inspect area between fins No. 2 and 3 in the 90° quadrant between rear spark plug and exhaust manifold. Using a strong light, and extra care at point 30° from spark plug check for cracks and discoloration caused by leakage of exhaust gases. Replace cylinder assembly if cracks or discoloration are detected.
